AGENDA OF THE  
REGULAR MEETING OF THE PLANNING  
COMMISSION  
CITY OF BIRCHWOOD VILLAGE  
207 BIRCHWOOD AVENUE  
WASHINGTON COUNTY, MINNESOTA  
JUNE 7, 2011  
7:00 P.M.

**DATE:** May 20, 2011  
**TO:** Planning Commission  
**CC:** City Planner Samantha Crosby  
**FROM:** Dale Richard Powers, MA, AICP, City Clerk  
**RE:** PC Review of Village Hall Building Inspection Report, and PC Recommendations on how to address the ADA compliance issues

On October 12, 2010, I performed an inspection of the Birchwood City Hall building located at 207 Birchwood Ave in the City of Birchwood Village. The purpose and intent of the inspection was to determine the condition and potential life expectancy of the building's major components, and recommend upgrades for the building where necessary.

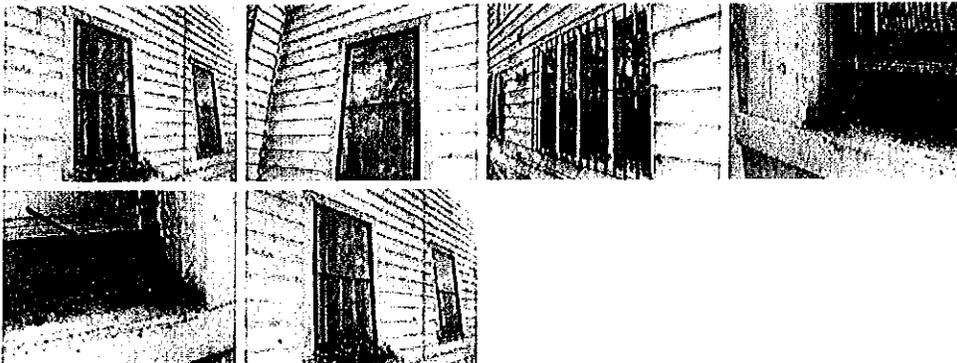
Windows: Wood Frame: It appears that bats are nesting in the siding and window jam area of one of the front windows. Pest control is recommended. Seal up gaps in siding to prevent further infestation.

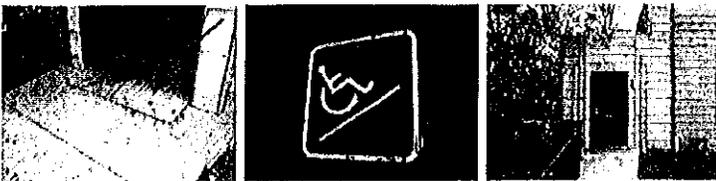
6. Entry Doors: Metal: The main entry door has a steep wood threshold installed to help smooth the transition from the sidewalk over the door threshold. Handicapped accessible doors should not have thresholds greater than 1/2" in overall height. The current threshold is steep and would be difficult for a person in a wheelchair to traverse.
